Building Renovation & Department Relocation Master Plan

BROWN SCHOOL - FINAL REPORT VOLUME I

MARCH 25, 2022

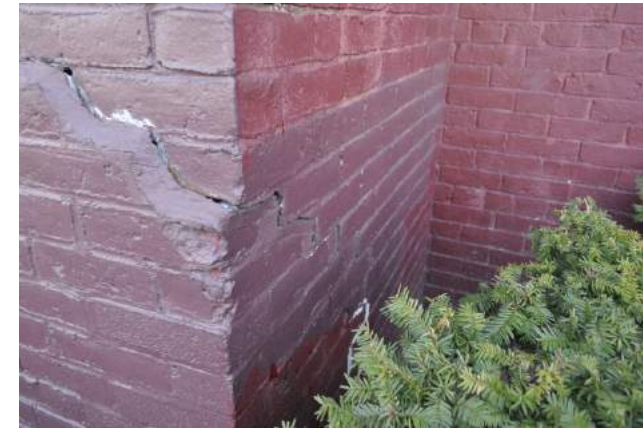
Masonry cracking and displacement, interface of 1901 and 1907 wings

Radiating zones of distress in the structure, envelope, and foundations were observed on the north and east facades, with the origination of these issues located at the north facade of the 1907 addition where it abuts the original structure. We noted significant movement (both vertical and lateral) of the exterior bearing wall that translated all the way through the wall. 7" of vertical displacement was measured across the floor of Classroom 107. There was evidence of cracking in the foundation walls, in the adjacent slab on grade as well as significant deflection of the floor structures above.

Our initial assessment was that this damage was caused by historical foundation settlement, and the team recommended a series of test pits and borings to confirm potential causes and whether it is still a dynamic condition. A prior crack monitoring survey and report was reviewed, and test pits and borings were executed in late 2021. Since the settlement occurred, and based on the observations in the test pits and recent crack gauge readings, the design team concludes that building

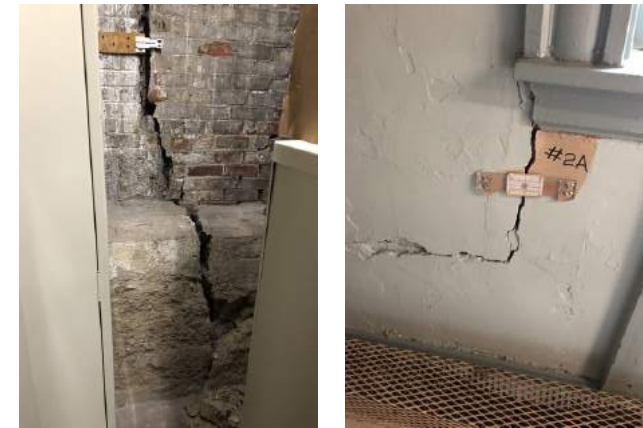
Interior view of wing interface; condition of interior finishes

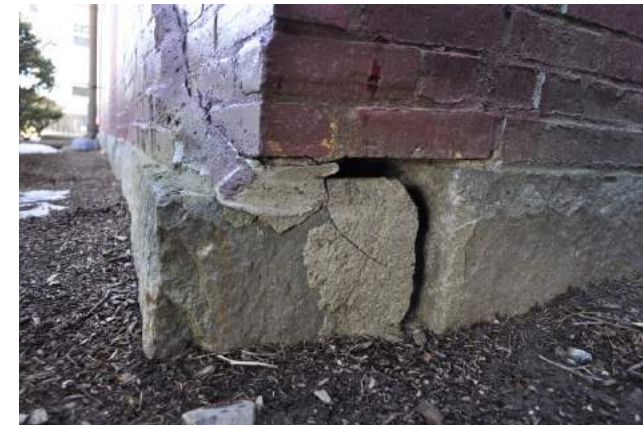
Settlement and displacement of granite foundation units

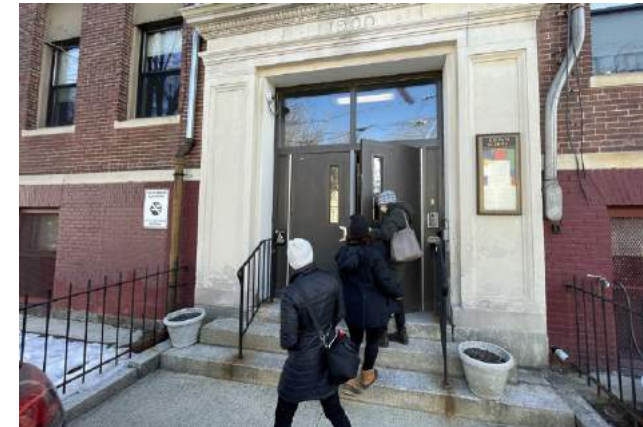
The non-original replacement doors are in fair to poor condition with numerous areas of corrosion and signs of heavy wear. The east and west stoops are in very poor condition and require full rebuild. The accessible ramped entrance on the north facade is constructed of concrete masonry units with a flat roof and should be removed with the reconfiguration of an accessible entry sequence into the building.

Main Entry and granite stoop

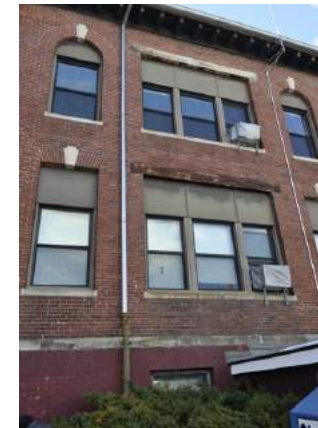
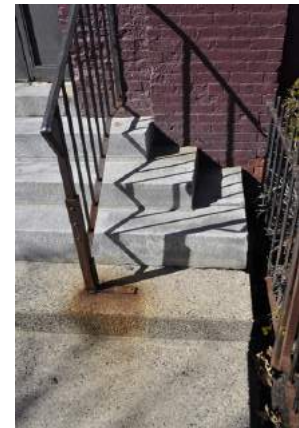
The facade masonry is in fair condition, except for the 1907 east wing which has significant settlement and displacement issues most pronounced on the north and east elevations. Apart from that zone, an estimated 25% of total wall area on the building will need repointing, with limited areas of full repointing, and areas of step-cracking near window heads and corners that will need to be addressed. Stone coursing, sills, and keystones will require 100% repointing and cleaning with selective repair for cracks and spalls. Chimneys are in fair to poor condition (particularly the northwest chimney) and will require full repointing as well as partial to full rebuilding from the roof upwards. The two south chimneys are missing chimney caps, and the southwest chimney is missing a coping unit; these should all be replaced.

Masonry conditions, North Facade; East Entry stoop and handrail

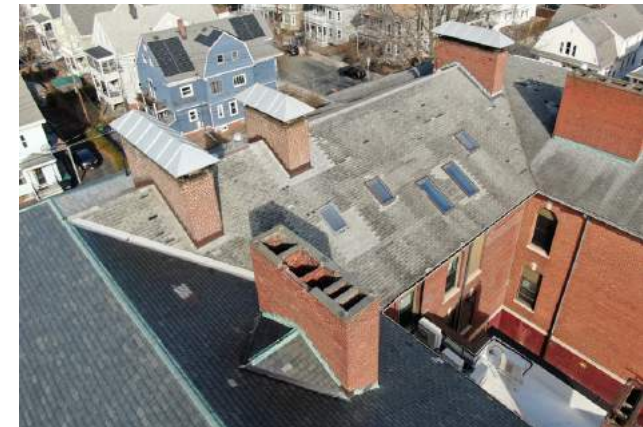
Drone photograph of Brown School roof

The roofs were surveyed using drone photography. The areas of slate roof look to be in fair to good condition overall. The composite asphalt roofing looks to be in fair condition, with visible patched areas where penetrations were re-flashed, and surface wear elsewhere. On the toilet wing, the low-slope membrane and parapet flashing looks to be in good condition, and is presumed to date from the last five years after the roof collapsed in this area circa 2015.

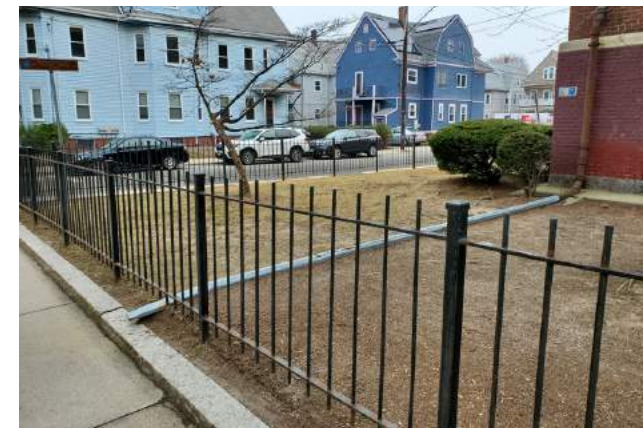
External downspouts daylighting to grade at the sidewalk

- A building addition and/or improvements planned for this site offer a major opportunity to improve site programming for the school. Currently, the school doesn't have a gym and play space is limited to the paved courts (no play structures).
- Site parking is very limited (1 "space"). Evaluate parking needs and identify strategies to increase dedicated parking, either on-street or within site.
- Small garden and composting bins observed. Opportunity to expand on outdoor educational classroom/rain garden for science study.
- Limited existing universal accessible route and entrances. This should be evaluated as part of any site improvement.
- Existing downspouts daylight to grade, a major opportunity for better stormwater management.

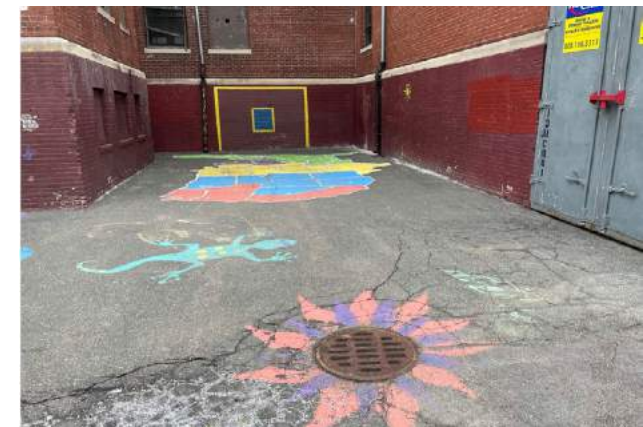
Catch basin in the paved schoolyard at the rear of the building

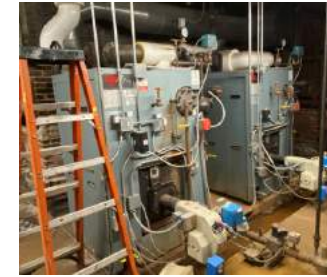
The primary heating source for the building is steam radiators. There are two (2) gas-fired low-pressure steam boilers in the first floor mechanical room, which are nearing the end of their service life [M1]. The boiler has a Honeywell control system [M2]. The condensate receiver and pumps are also nearing the end of their service life [M3]. Standing water was observed in the mechanical room, however the source was not identified. The third floor is not served by the main heating system. Two (2) gas-fired boilers are abandoned in place in the attic [M4], and these spaces, including the library and storage areas, are heated and cooled with Fujitsu mini-split heat pumps with outdoor units on the flat roof [M5]. There is no mechanical ventilation.

M1, M2. Gas-fired boilers, controls

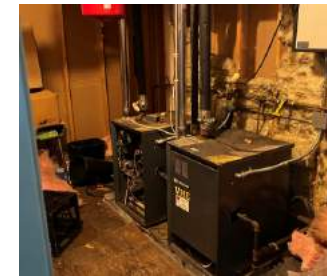
M4, M5. Abandoned gas-fired boilers on Third Floor, replaced with mini-splits

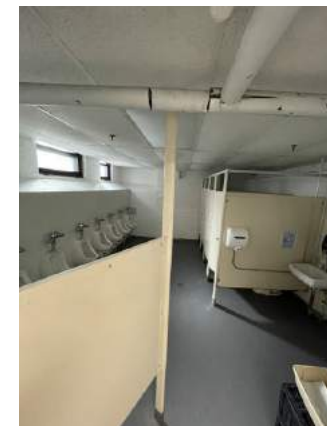
The water service and meter were not accessible during the site visit. Basement and attic have sprinklers. Plumbing fixtures throughout the building appear in fair condition but are outdated [P1].

P1. Basement toilet room
