# SOMERVILLE IDDE INVESTIGATION: PERMIT YEAR 4 CATCHMENT INVESTIGATION

TO: Lucica Hiller, City of Somerville, Stormwater Manager  
CC: Todd Prokop – Woodard & Curran  
Garrett Bergey – SDE  
FROM: David Moering and Chelsea Waite – Woodard & Curran  
DATE: September 23, 2022  
Revised October 14, 2022  
RE: Somerville IDDE Investigation – Permit Year 4 Catchment Investigation Memo  
Revision No. 1

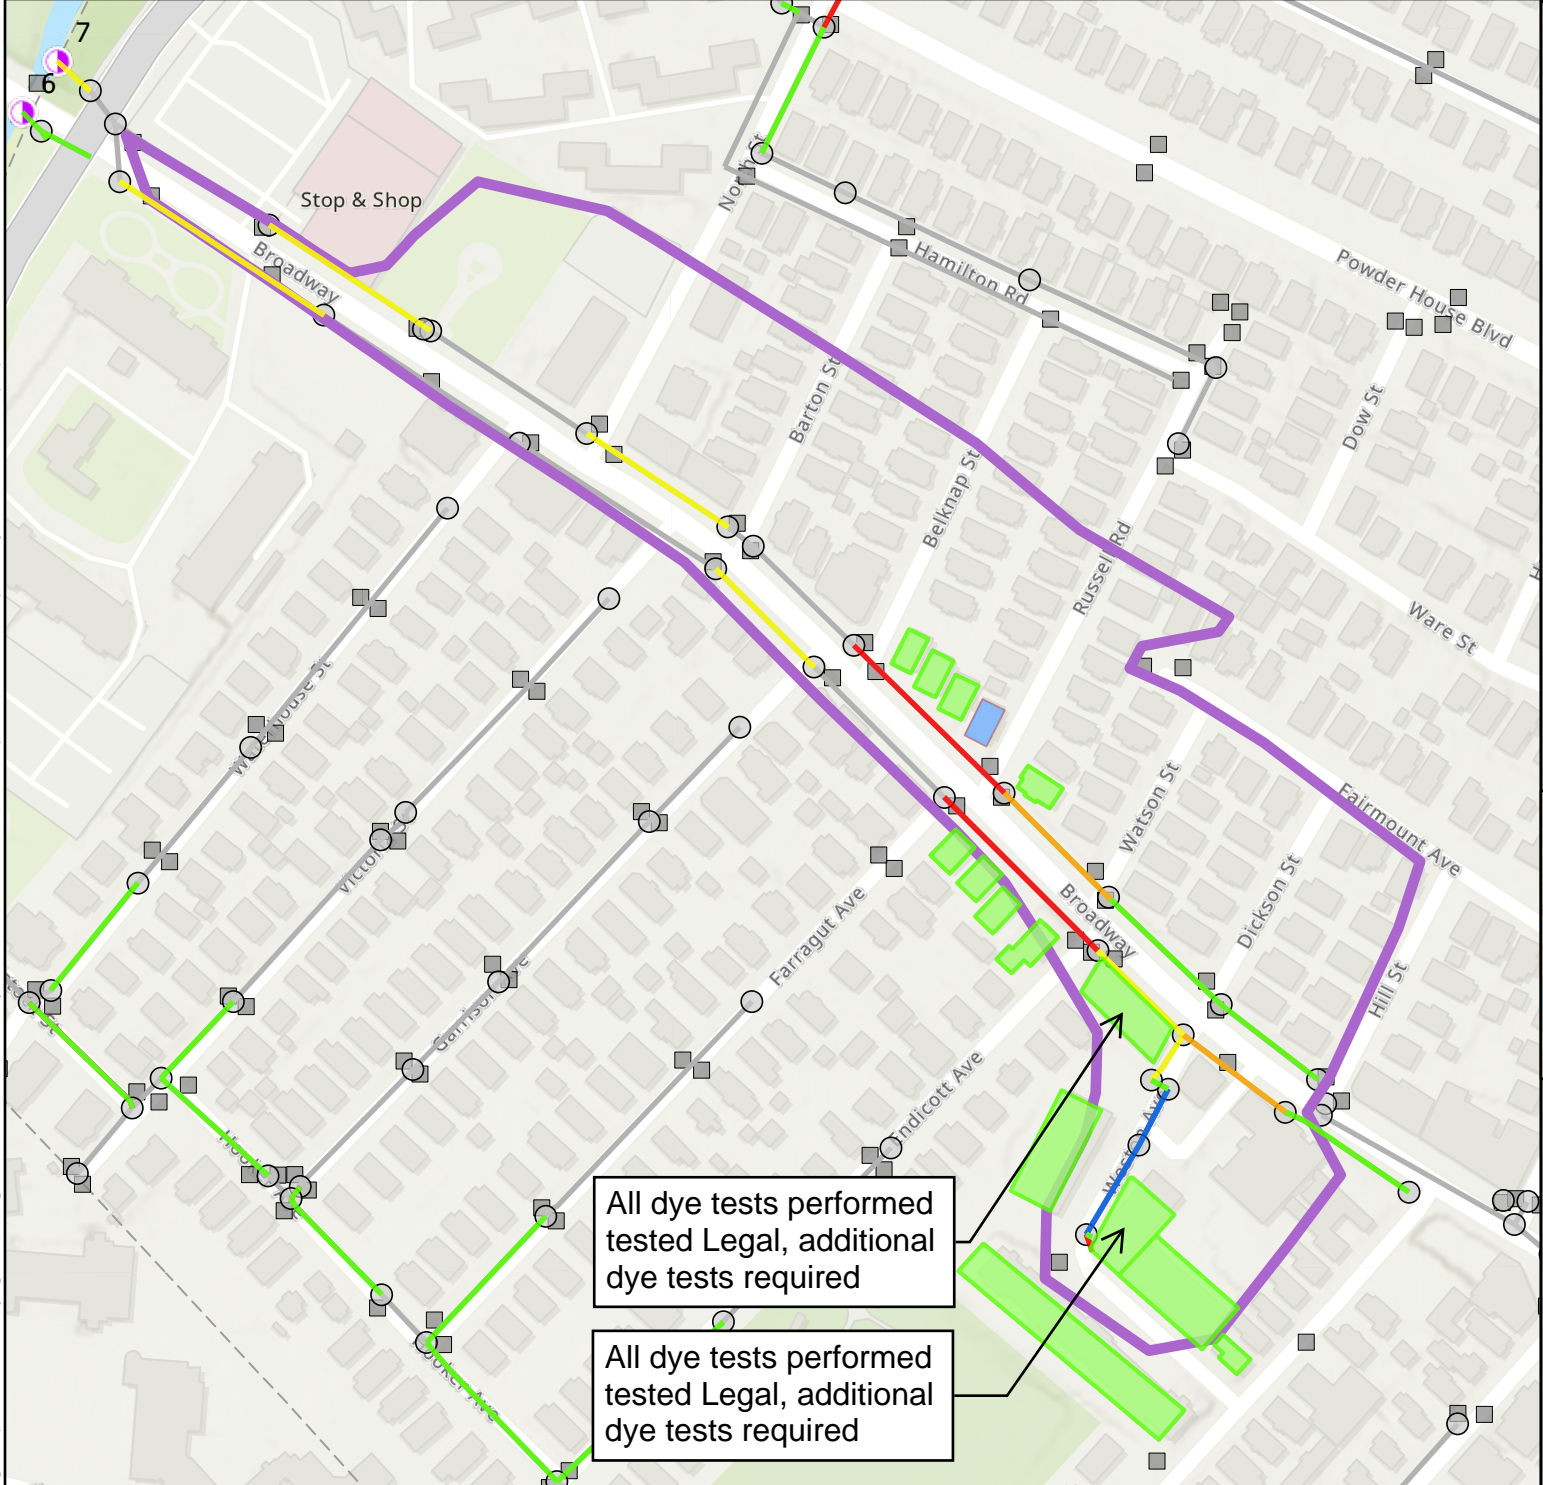
## Catchment 7

All dye tests performed tested Legal, additional dye tests required

There are two remaining areas in Catchment 7, storm drain manholes 7-5827 and 7-5833, where the source of contamination is still not known. For next steps at storm drain manhole 7-5827, the City plans to perform additional inspections at all units in 1198 Broadway. For next steps at storm drain manhole 7-5833, the City plans to review any available record drawings at 16-42 Weston Avenue and complete thorough building inspection dye testing in every unit in the building.

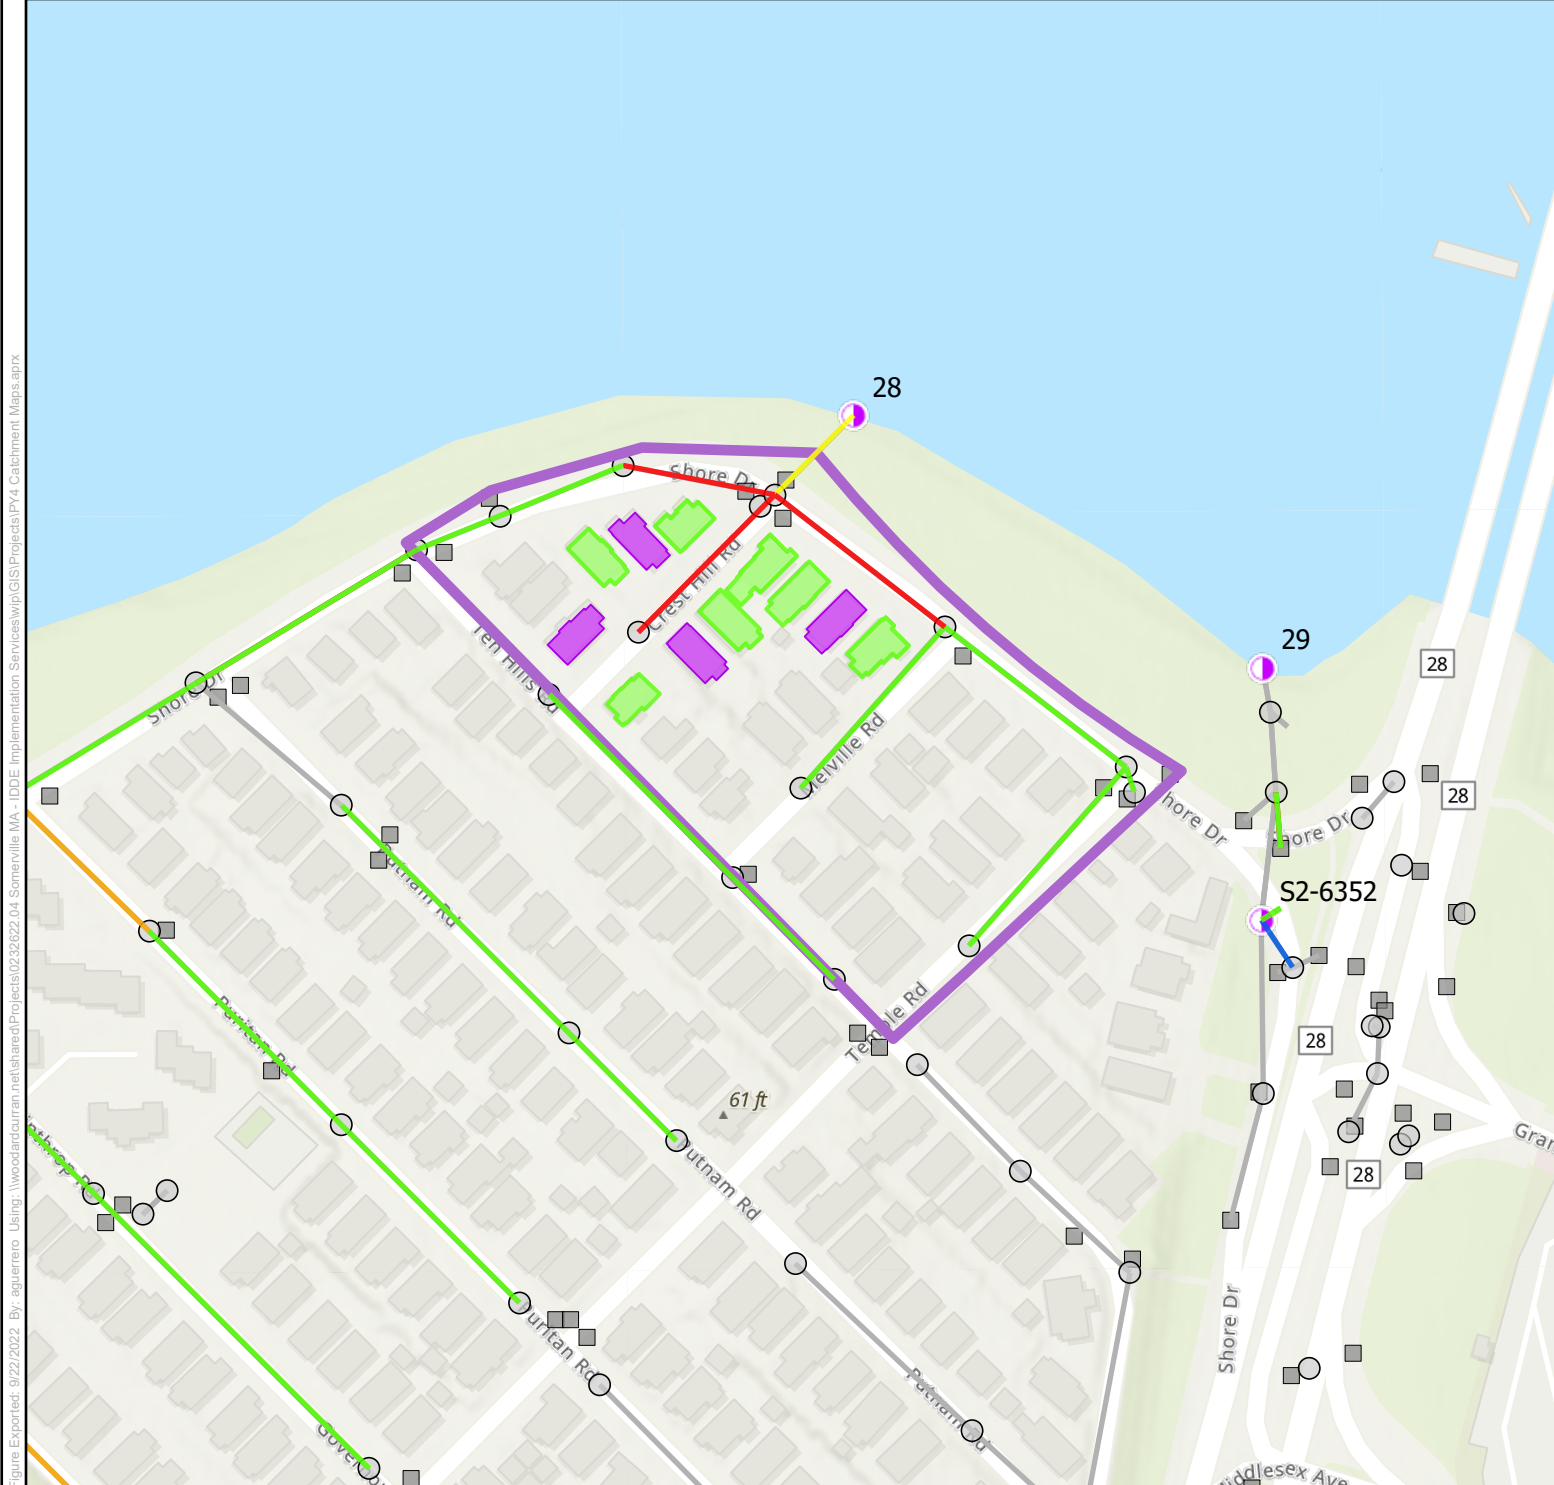
## Catchment 28

Based on the building inspections completed during Permit Year 4, the City has not found the source of the suspected illicit connections in Catchment 28. The source of contamination at storm drain manhole 28-5105 is not known as all completed building inspections yielded Legal results.

For next steps at storm drain manhole 28-5105, the City plans to reattempt building inspections at 9 Crest Hill Road, 95 Shore Drive, 115 Shore Drive, and 125 Ten Hills Road. The City plans on making additional calls to property owners and mailing a more strongly worded letter to the homeowners.

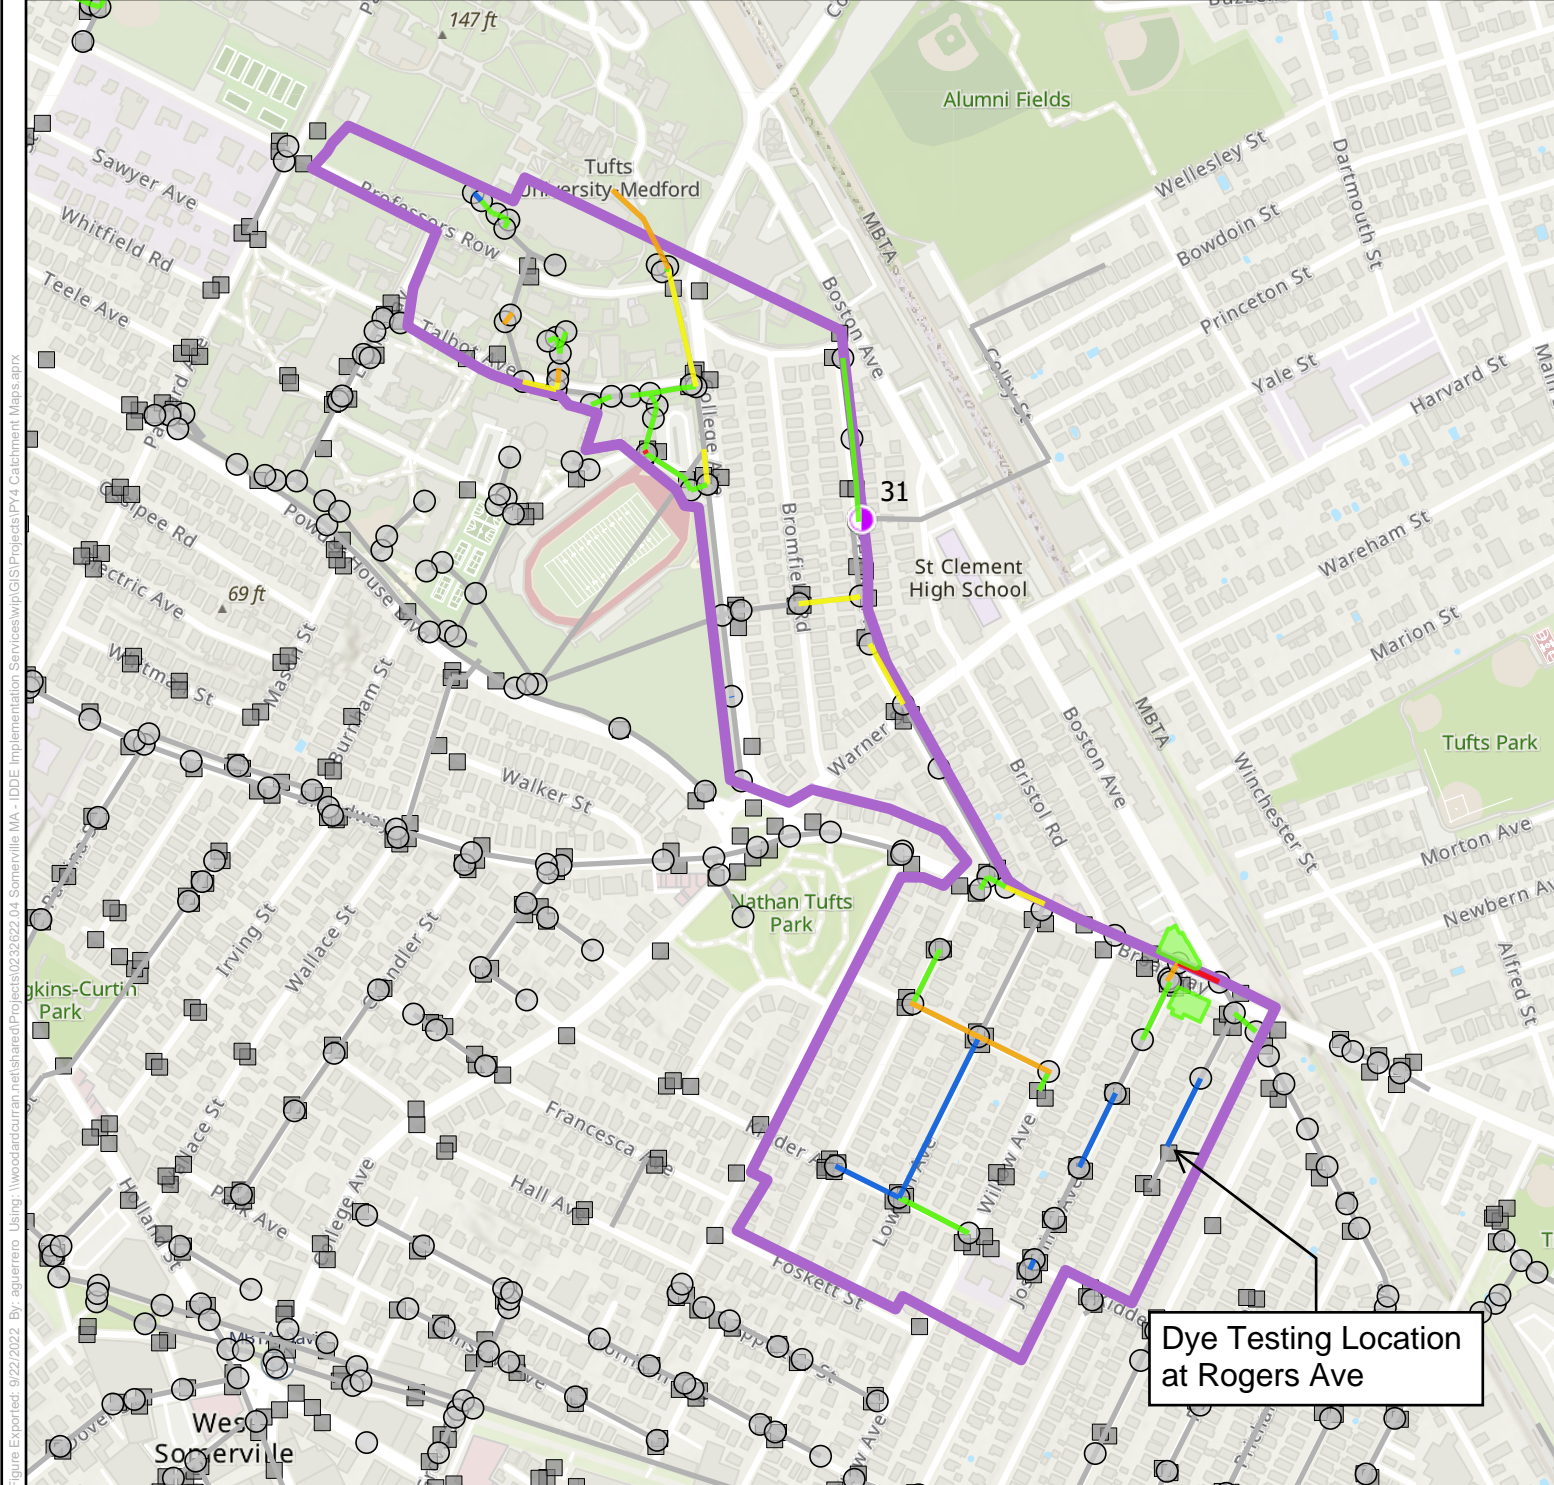
## Catchment 31

Based on the building inspections completed during Permit Year 4, the City has not found the source of the suspected illicit connections in Catchment 31. The source of contamination at storm drain manhole 31-6455 is not known as all completed building inspections yielded Legal results.

Dye Testing Location  
at Rogers Ave

For next steps at storm drain manhole 31-6455, the City plans to dye test the sewers on Broadway, adjacent to the manhole.

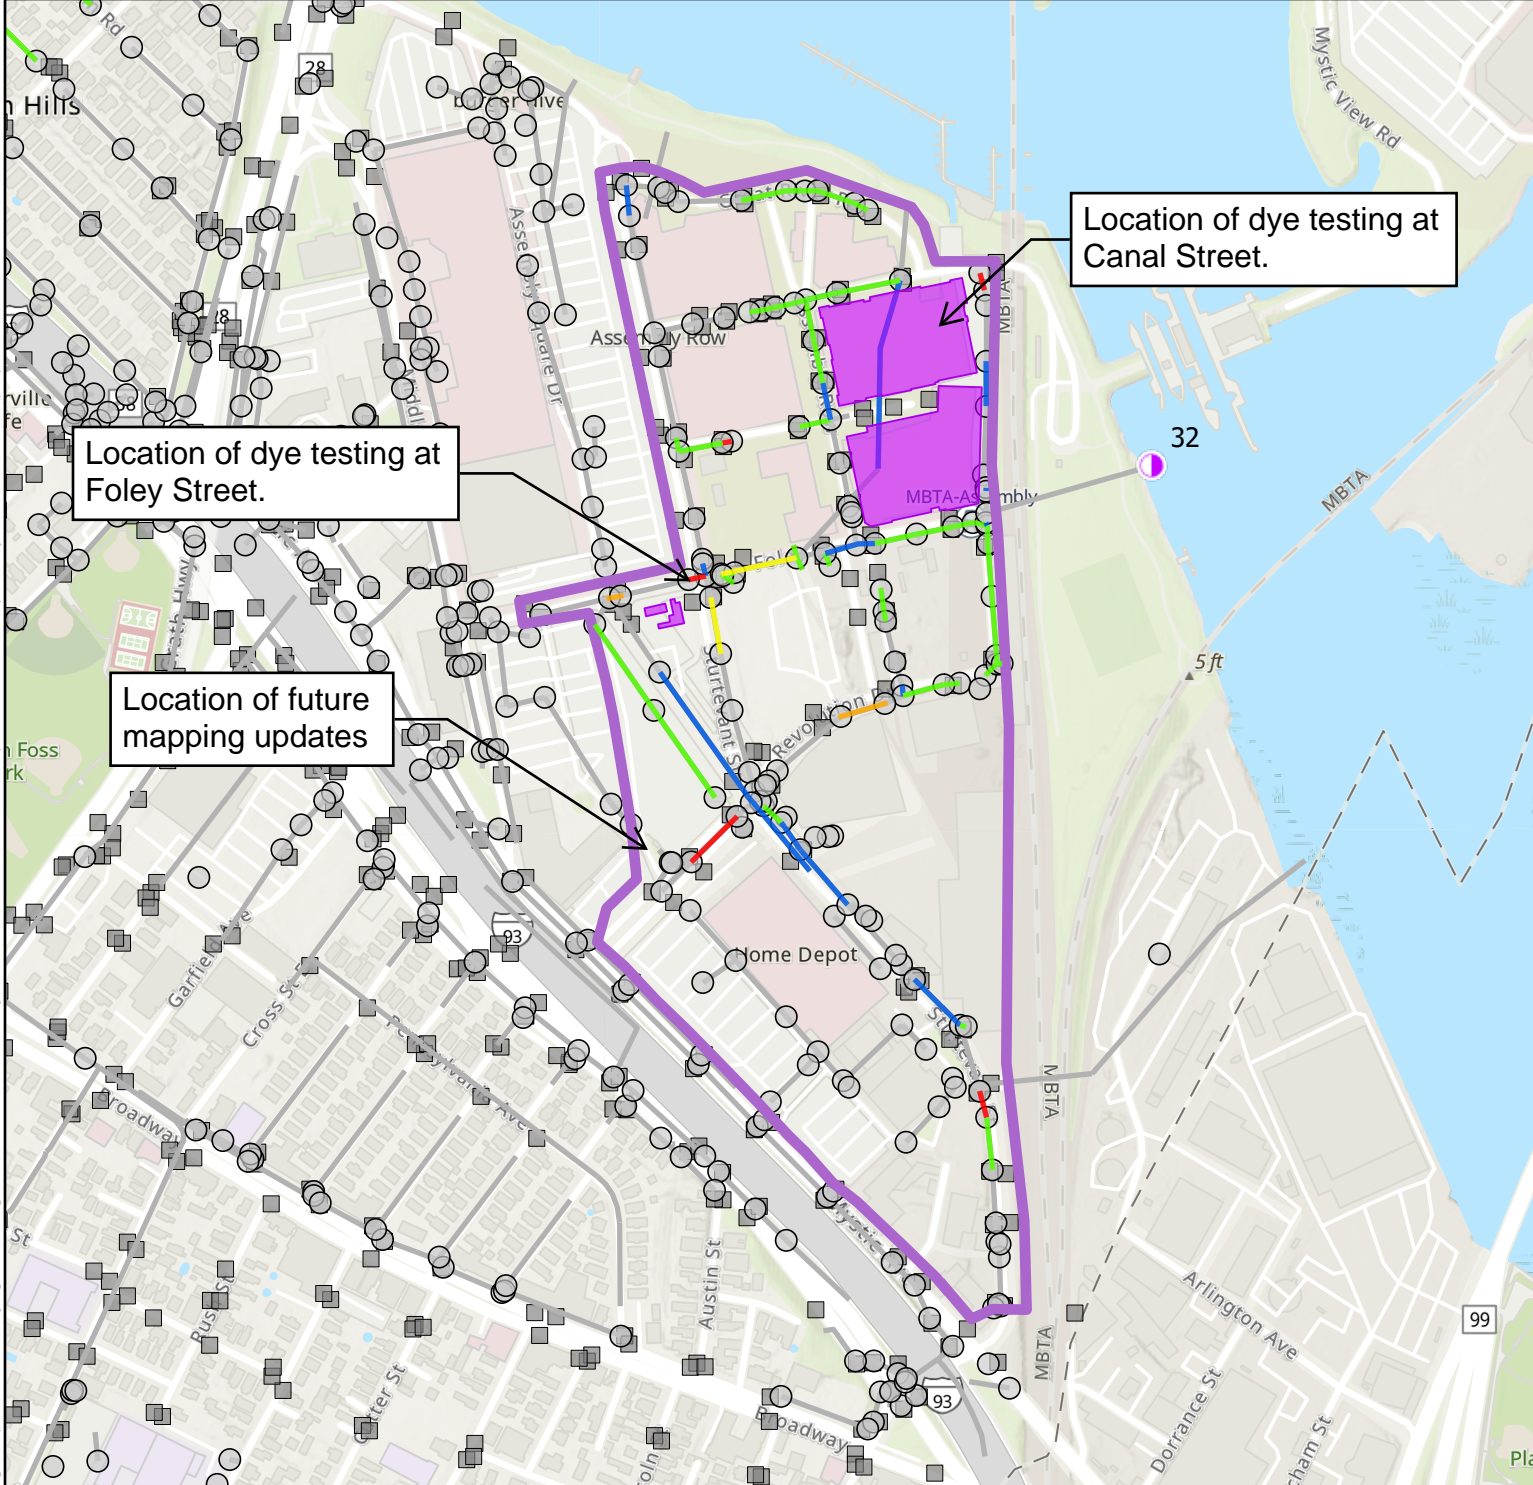
## Catchment 32

Location of dye testing at Canal Street.

Location of dye testing at Foley Street.

- Storm Drain Manhole 32-6265 at Revolution Drive
  - Update GIS mapping based on recent record drawings. These record drawings show infrastructure upstream of the contaminated pipes that are not mapped in the City's GIS. Once mapped, the City will sample the upstream infrastructure to isolate the area of contamination.

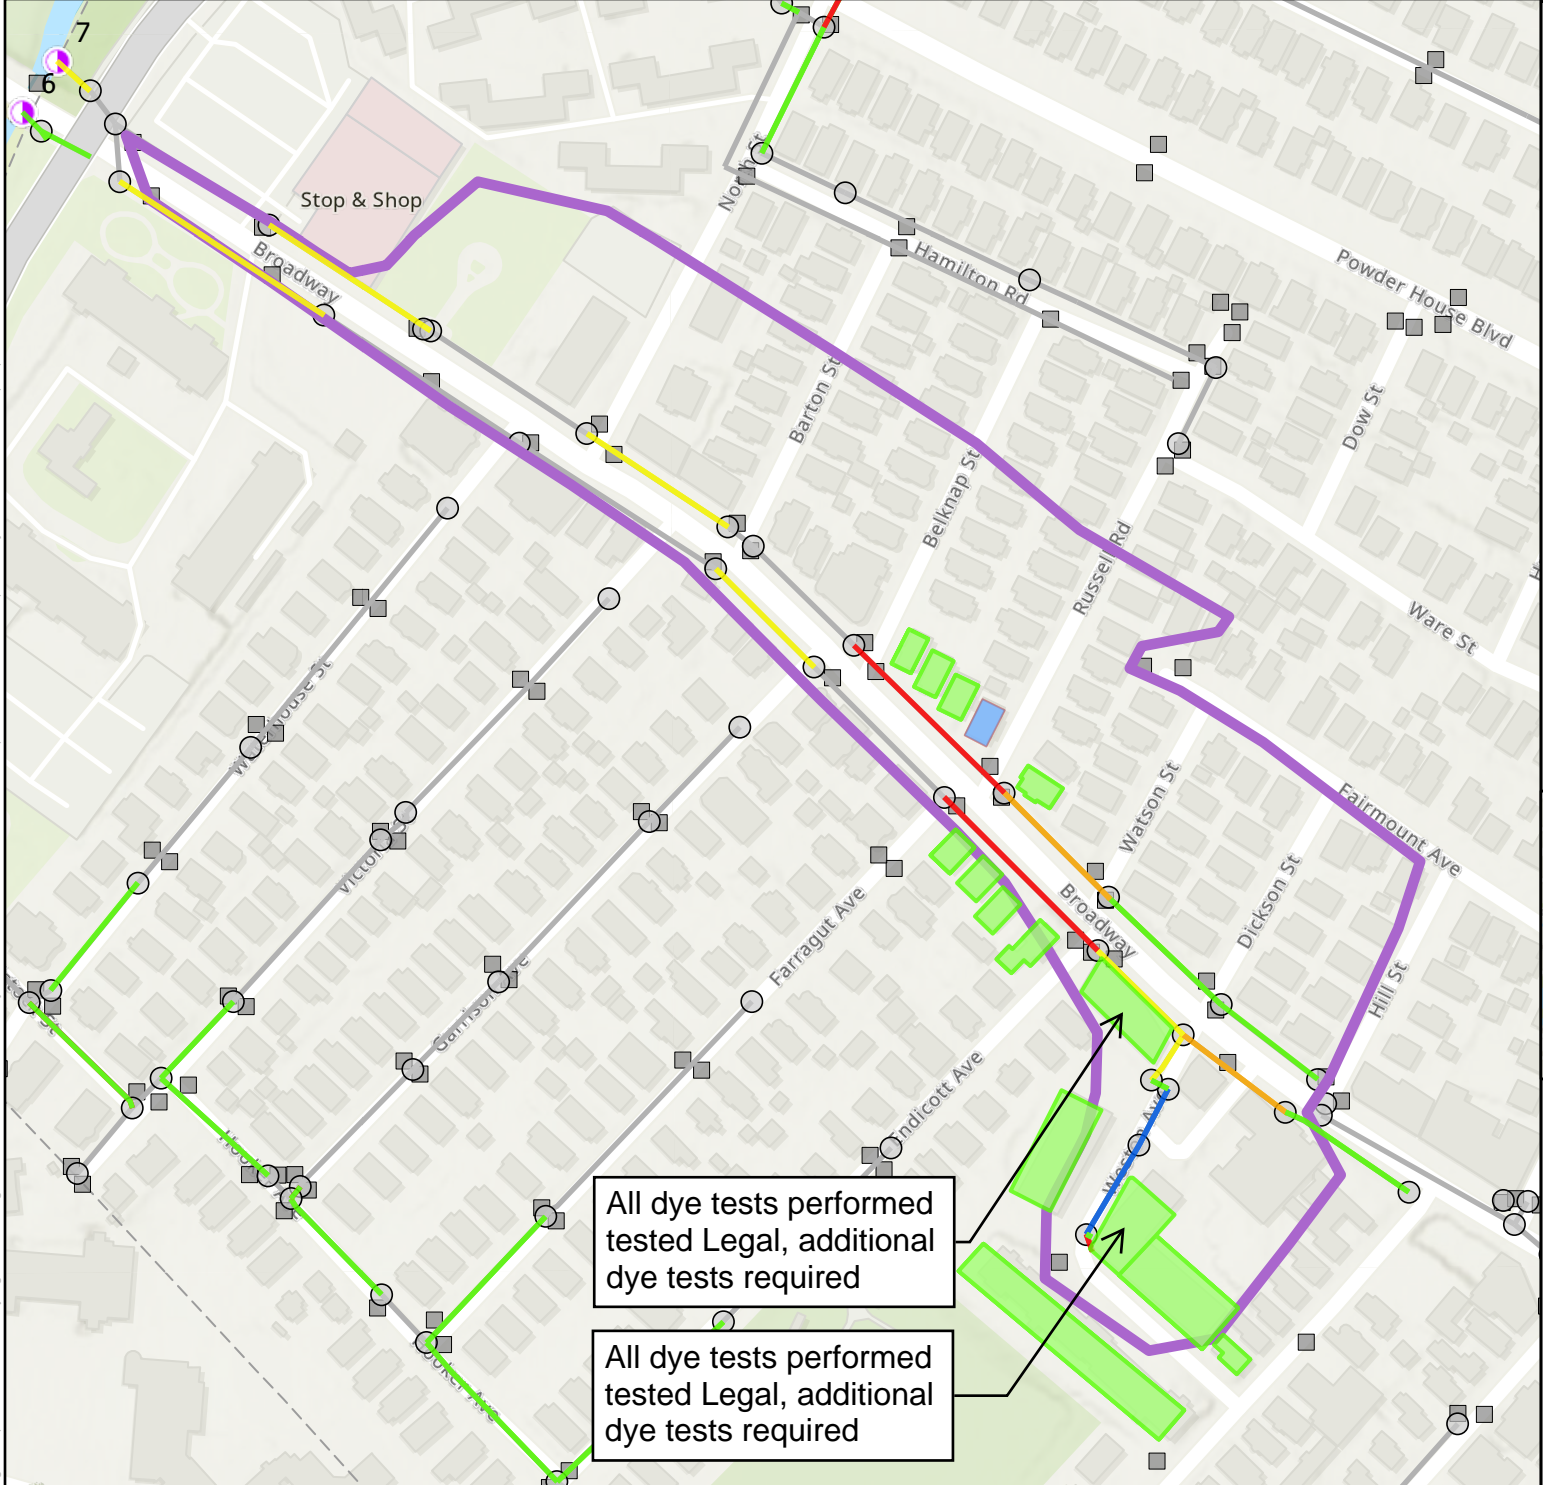
All dye tests performed tested Legal, additional dye tests required

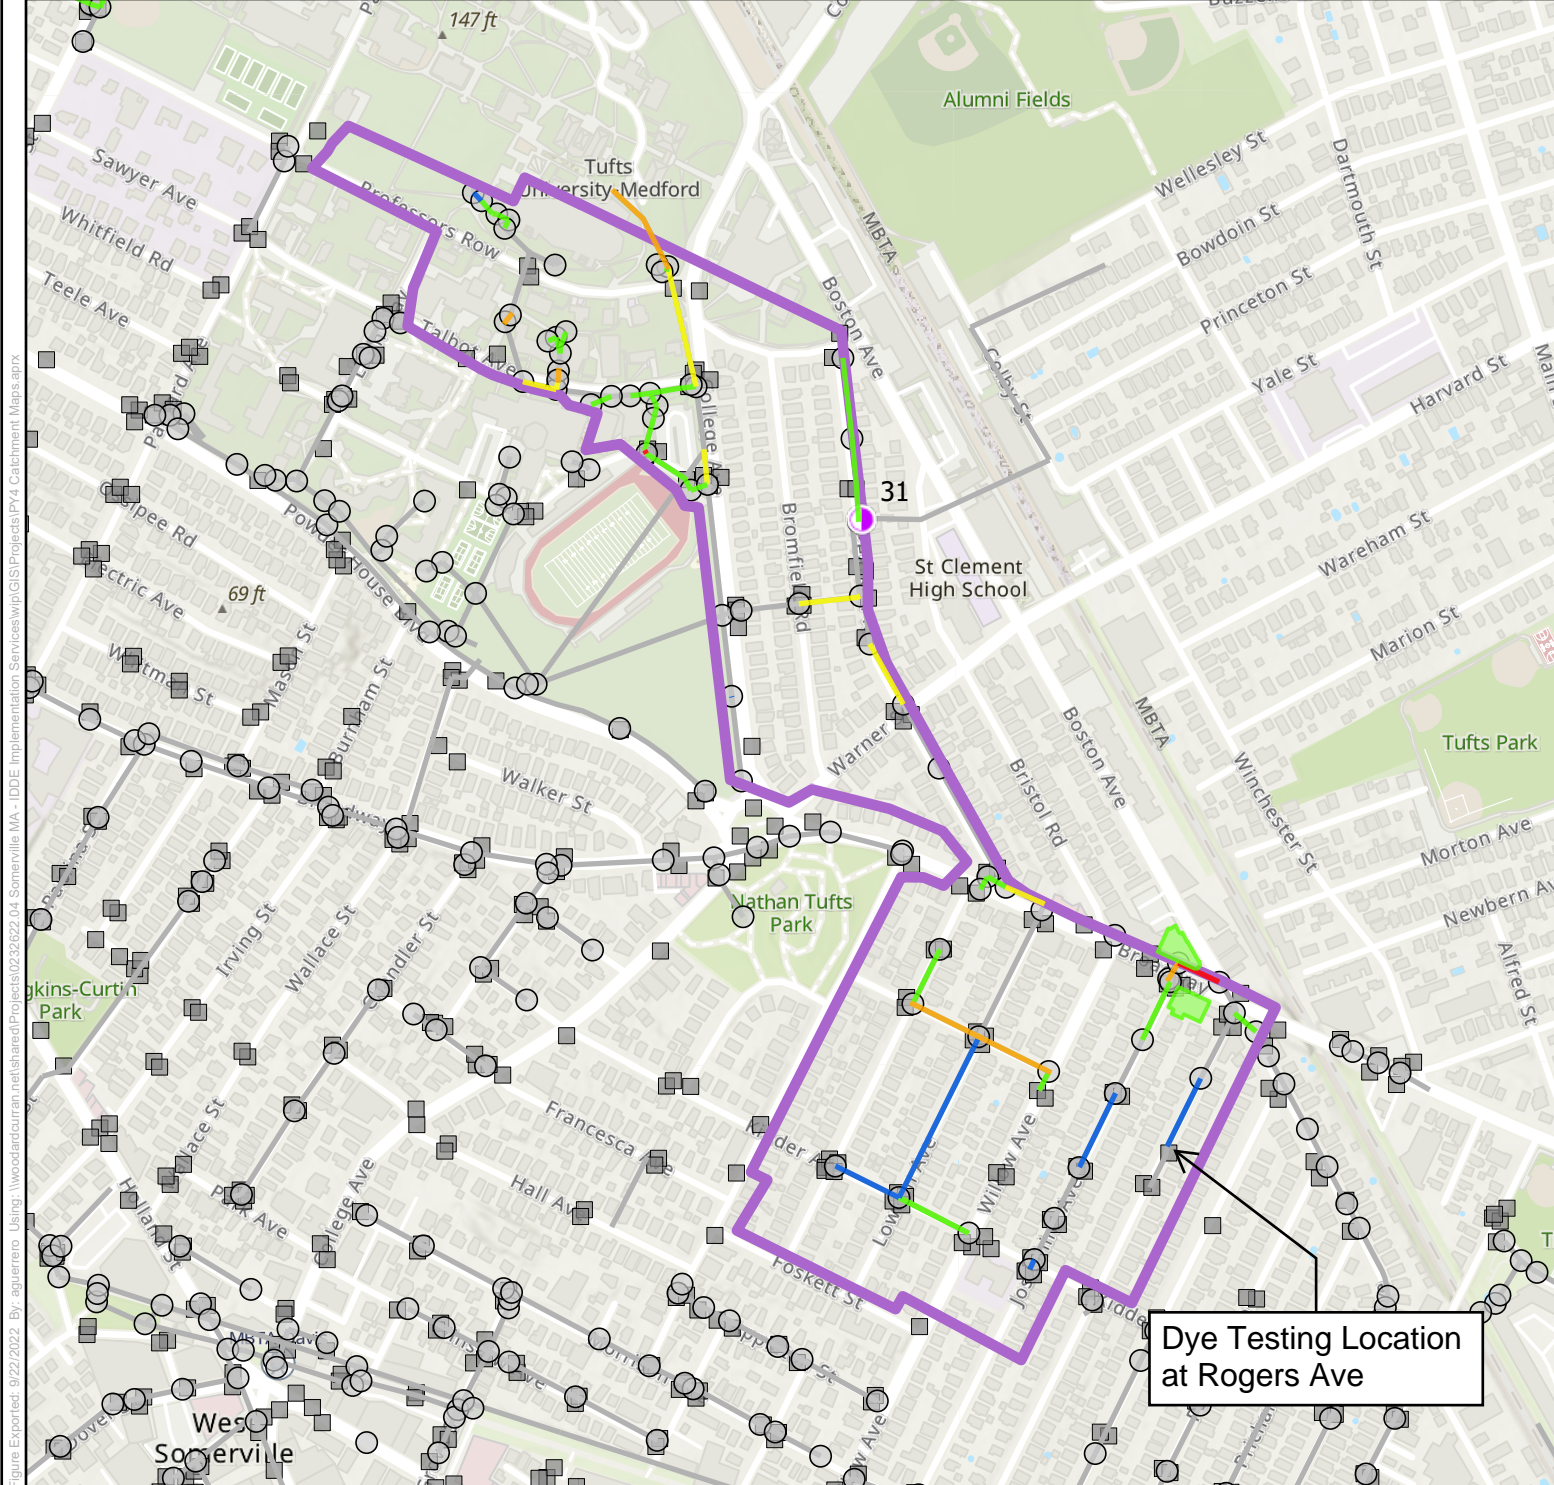
Dye Testing Location  
at Rogers Ave
