Tree Health Assessment Report
Kenney Park

Somerville Parks Tree Health Program

IFB #23-26

January 31, 2023

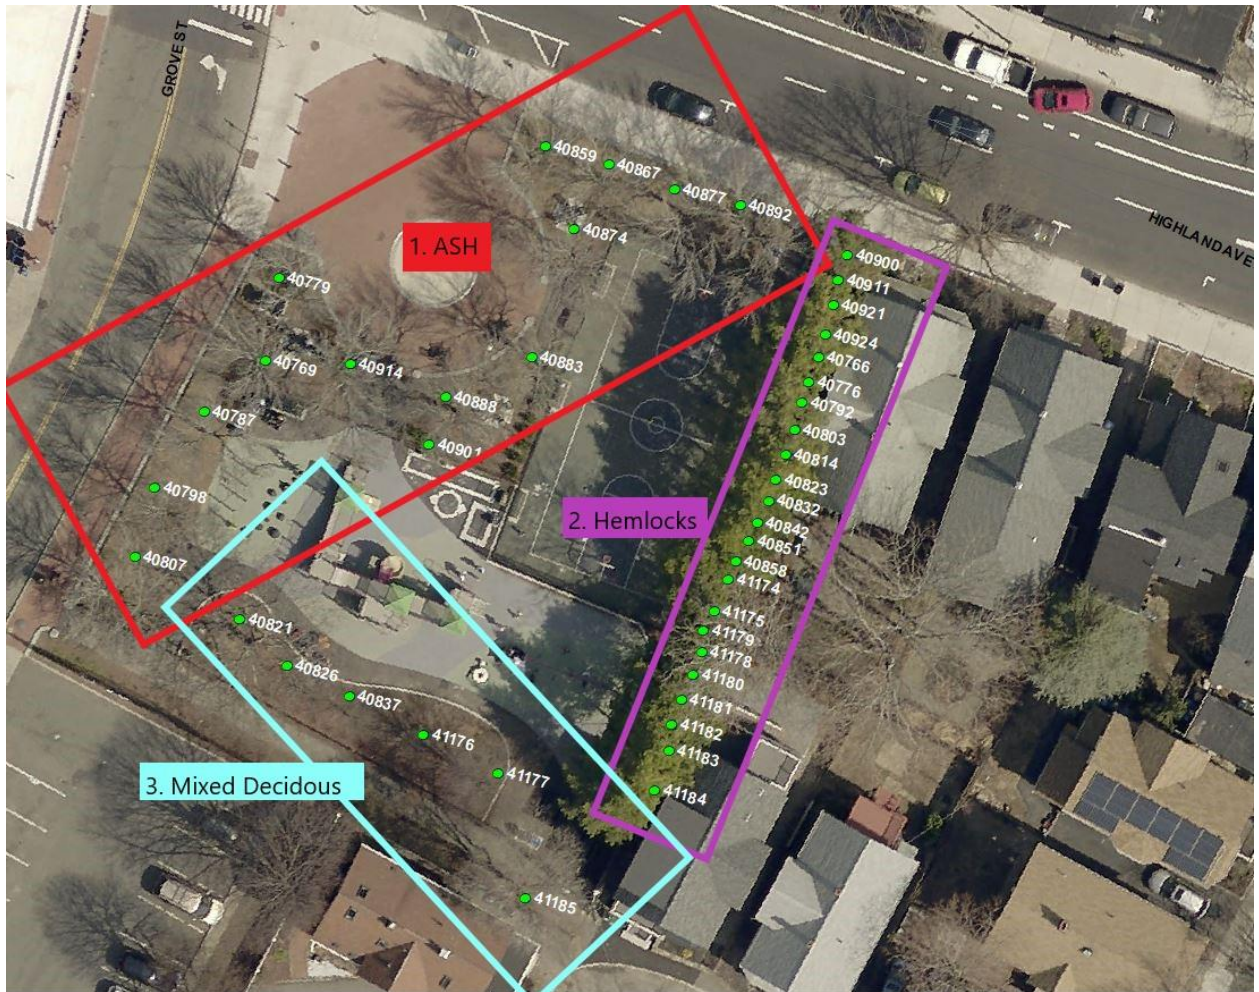
Kenney Park With Tree Zones

The trees in the park consist of three major tree groupings outlined in the attached map:

- 1. Mature Ash trees along the northern, central and western sidewalks. The main concern of these trees will be Emerald Ash Borer infestation in the coming decade. Treatment and monitoring should be prioritized going forward to preserve these trees.

- 2. Row of Hemlocks along the eastern border of the park. The Ash and Hemlock trees are in fair health, but both species are host to major invasive insect pests and will be under pest pressure and risk of infestation for the coming decade. (more in Pest section below). A few of the Hemlocks are already dead/declining or need root pruning.

- 3. Grouping of deciduous trees in the southern playground area (Honeylocust, Katsura, Tree Lilac and Elm). These trees are largely young-mature, durable species that have good overall vigor despite a challenging urban site. Given the crowded side these trees are encroaching on each other and surrounding structures which can be mitigated through pruning. Limited root area and poor soil are the main stress factors these trees in the third grouping.
