# City of Somerville

## Building Renovation & Department Relocation Master Plan

PREFERRED SCHEMATIC REPORT APPENDIX VOL. 1

NOVEMBER 24, 2021

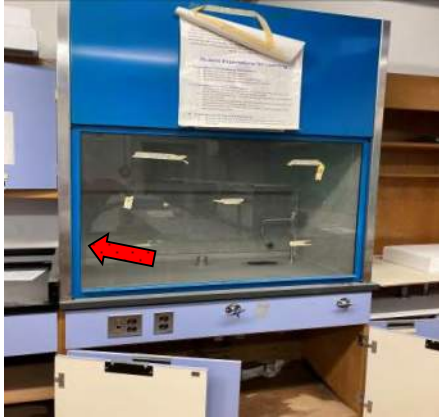
**Photo 1**

View of Asbestos-Containing Lab Hoods

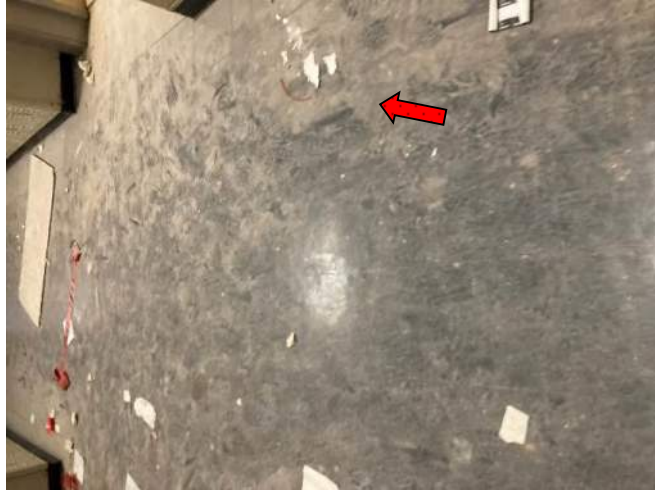
**Photo 2**

View of Asbestos-Containing 12" Dark Gray Floor Tile Mastic

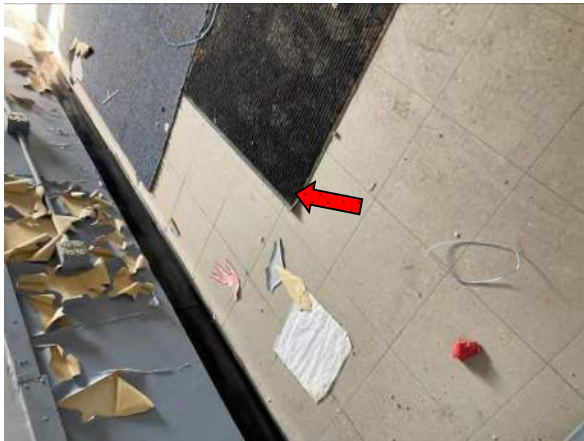
**Photo 3**

View of Asbestos-Containing 12" Light Gray Floor Tile Mastic

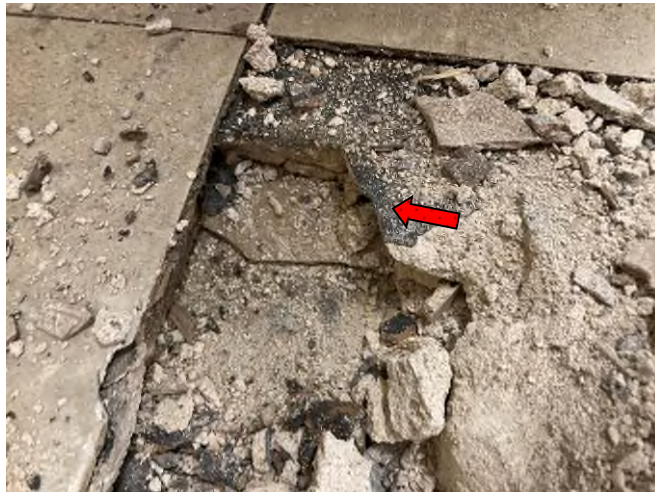
**Photo 4**

View of Asbestos-Containing 9" Tan/Gray Vinyl Floor Tile

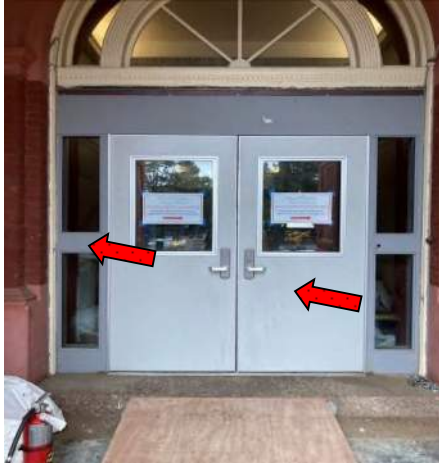
**Photo 5**

View of Asbestos-Containing Exterior Door  
Caulking, Exterior All Sides of Building

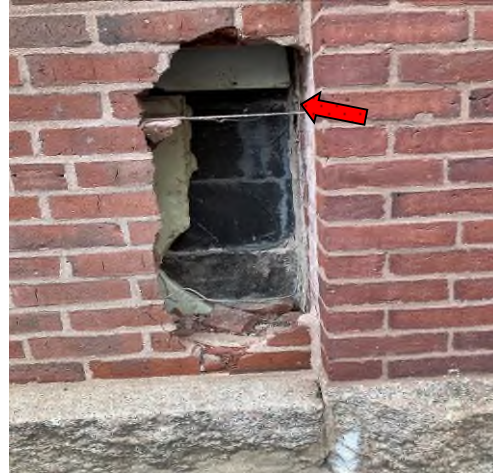
**Photo 6**

View of Asbestos-Containing Waterproofing  
Mastic

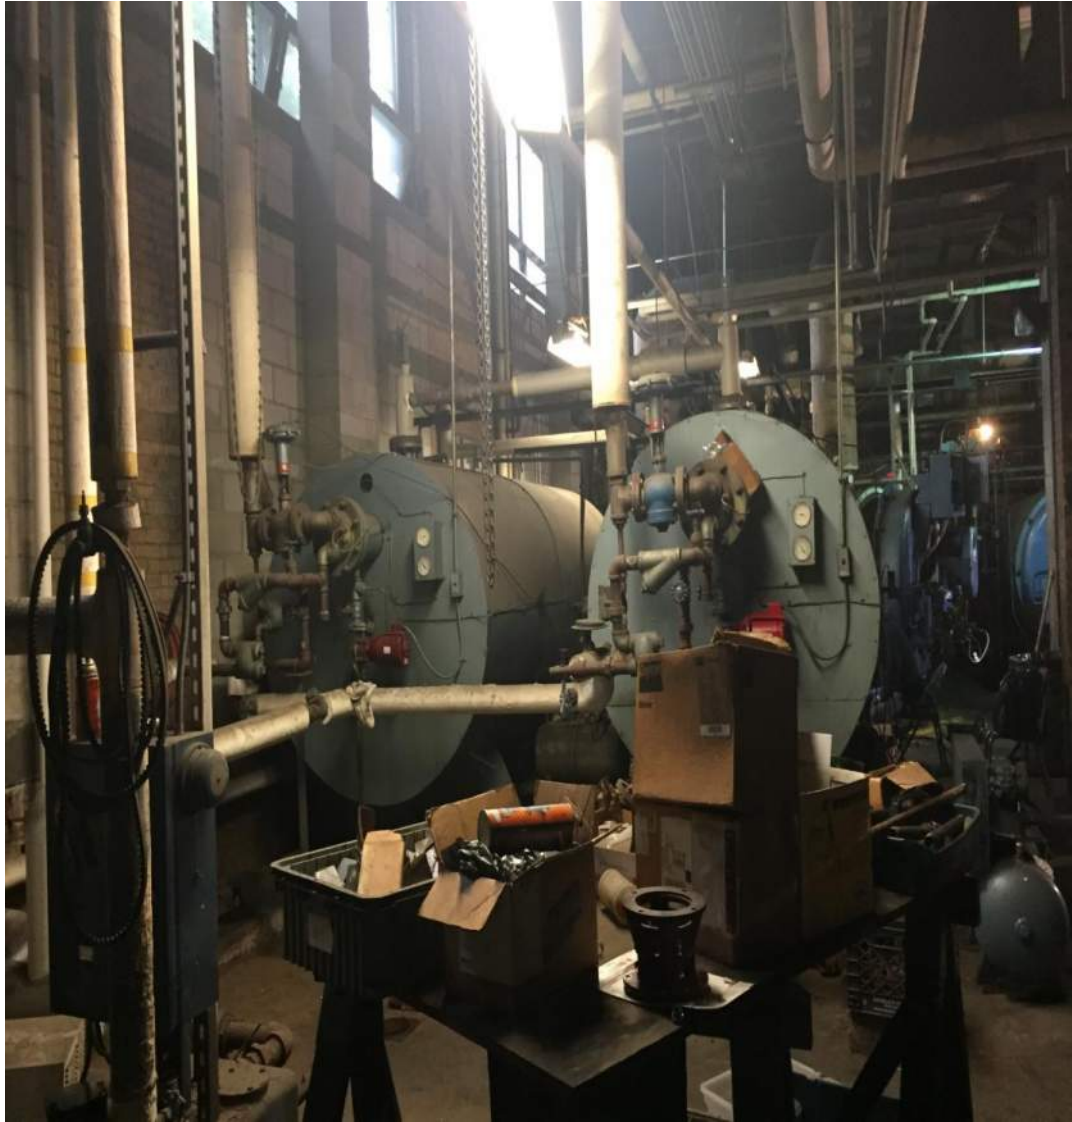
**Boiler Room with Fiberglass Pipe Insulation**

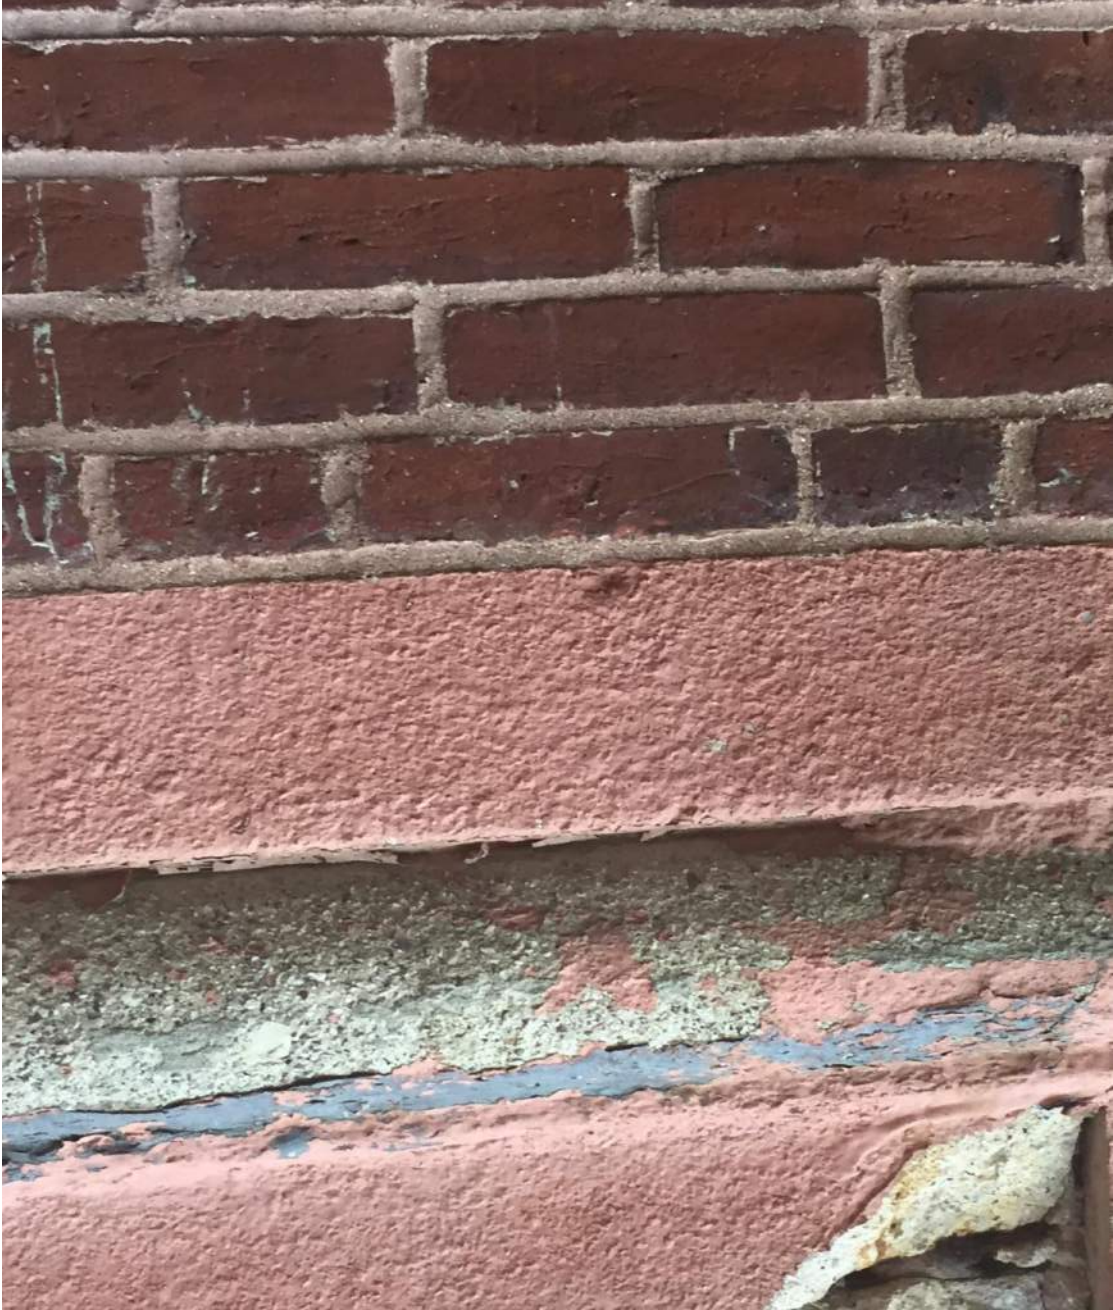
**ACM Tar on Coping 1929 D Wing**

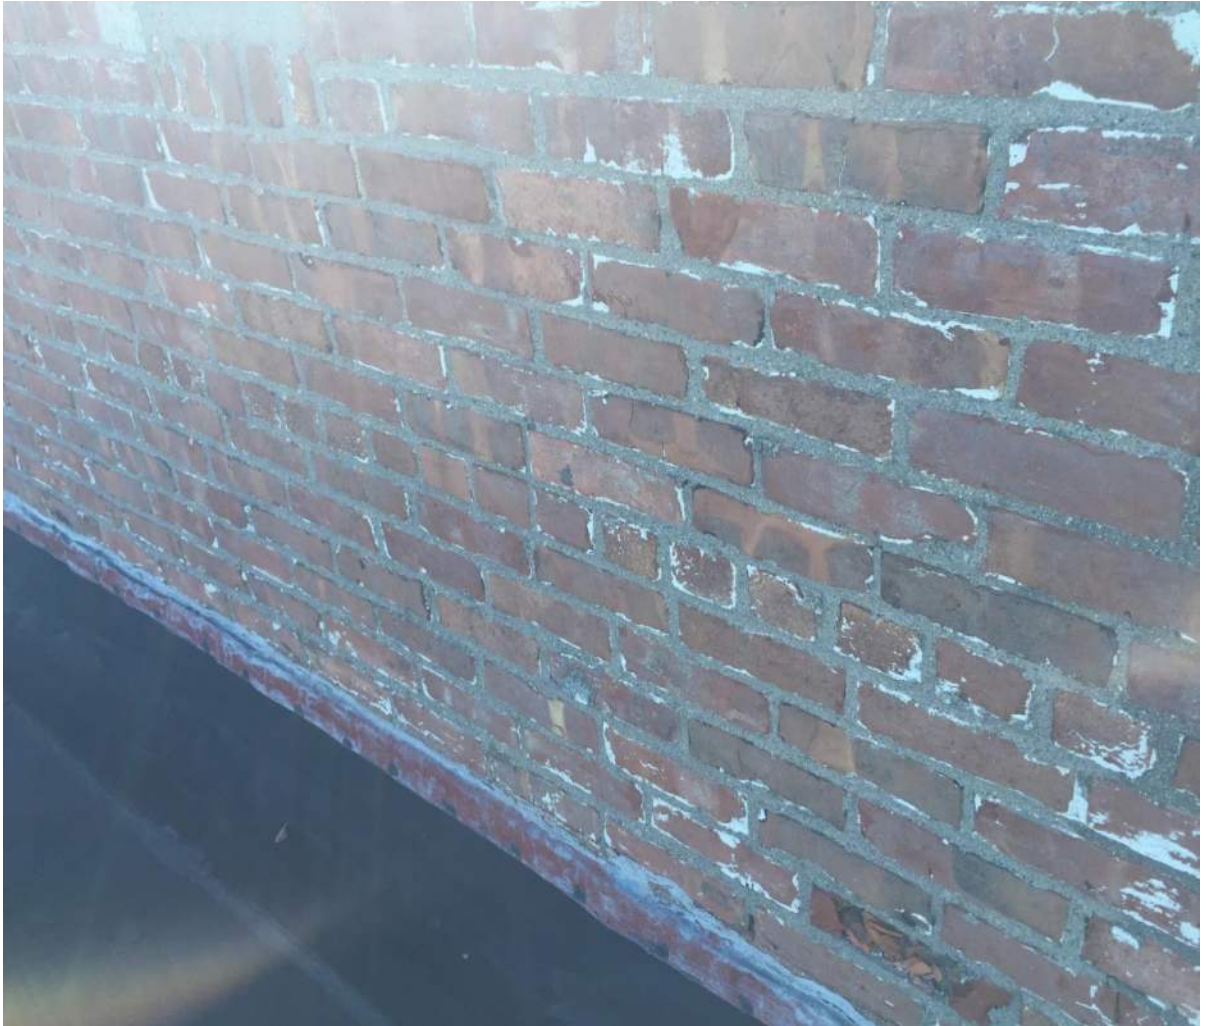
**ACM Caulk on B Wing Roof Auditorium**

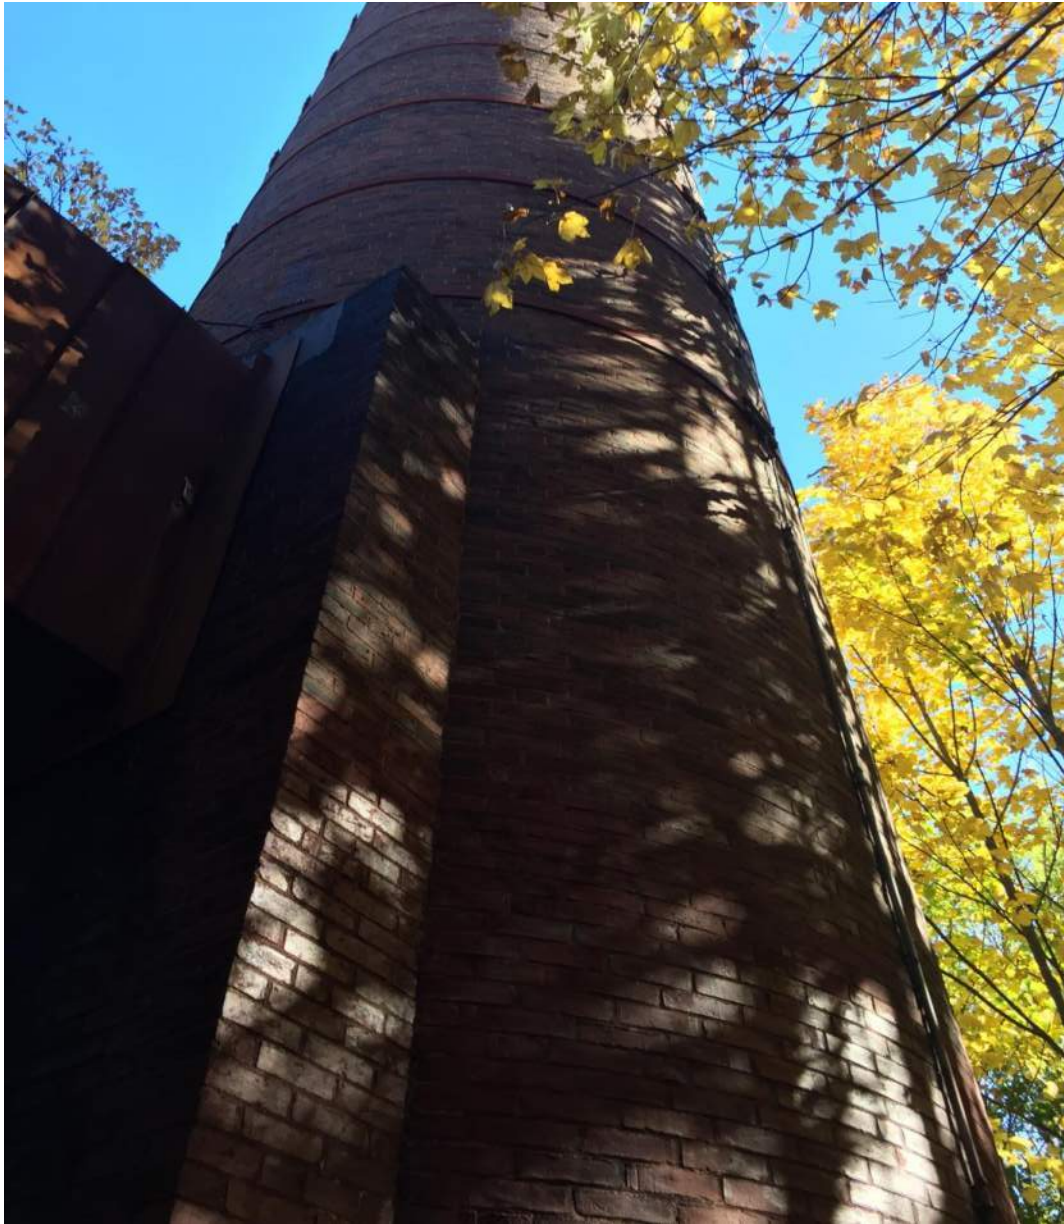
**Older Chimney With Possible ACM**

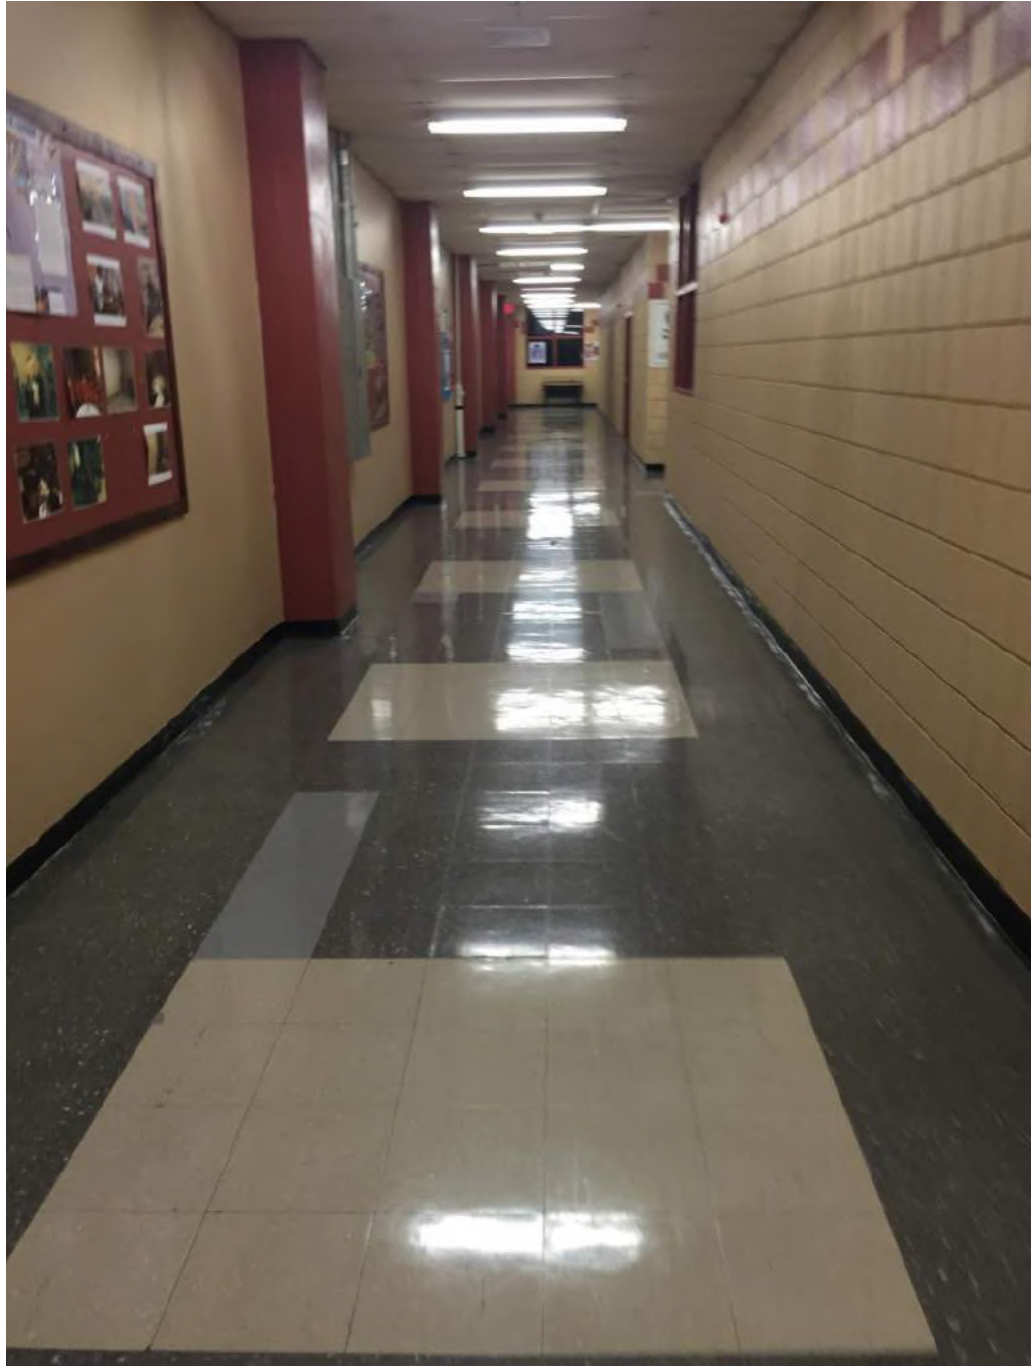
**ACM Floor Tile in 1988 Wing**

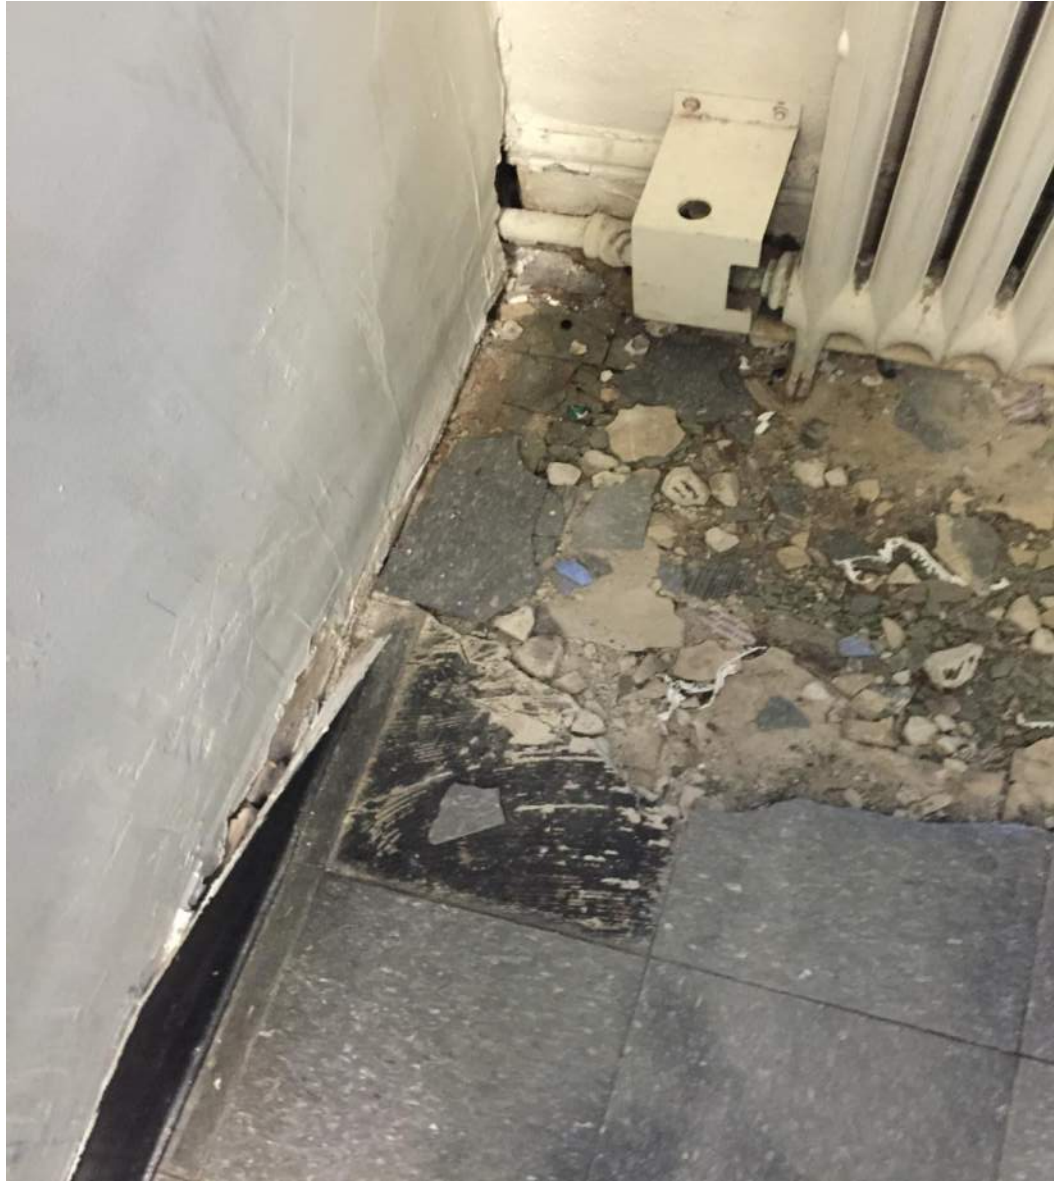
**Multiple Layers ACM Flooring B Wing**

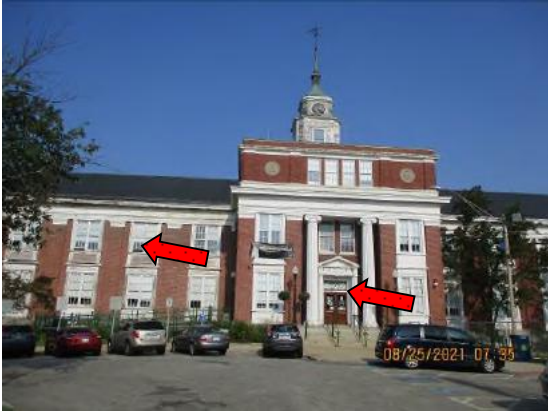
**Photo 1**

View of Asbestos-Containing Exterior Door and Window Caulking, Exterior All Sides of Building

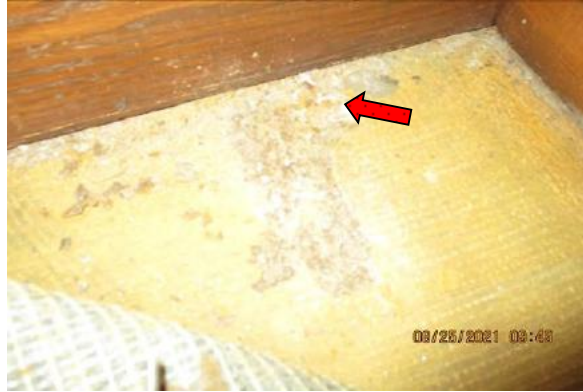
**Photo 2**

View of Asbestos-Containing Pebble Patterned Vinyl Sheet Flooring (under carpet & non-ACM flooring & on concrete), 1<sup>st</sup> Floor Offices West & Hallways East

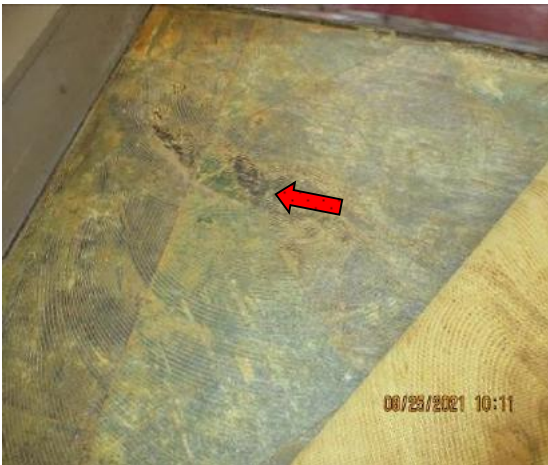
**Photo 3**

View of Asbestos-Containing 9" x 9" Green/Black Checkered Vinyl Floor Tile (under carpet, under other Non-ACM flooring & on concrete), 2<sup>nd</sup> Floor, City Council Chamber Room & Mayor's Office

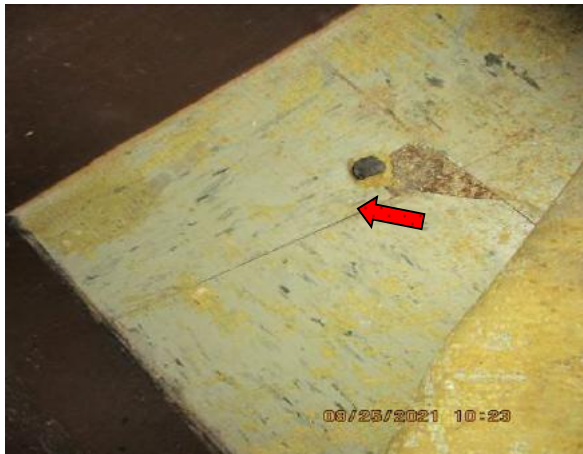
**Photo 4**

View of Asbestos-Containing 12" x 12" White w/ Gray Flecks Vinyl Floor Tile (under carpet & on concrete), 2<sup>nd</sup> Floor, Committee Room & 3<sup>rd</sup> Floor, Planning Board Office

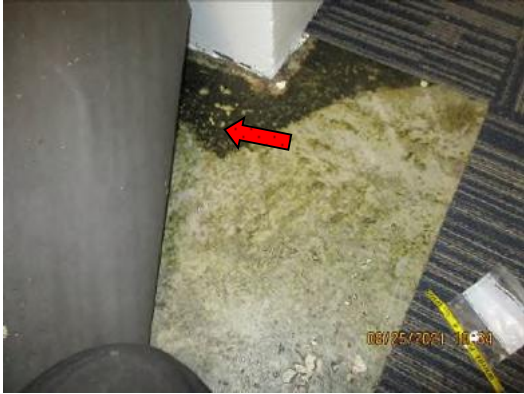
**Photo 5**

View of Asbestos-Containing Remnant Black Tile Mastic (under carpet & on concrete), 2<sup>nd</sup> Floor Mayor's Office

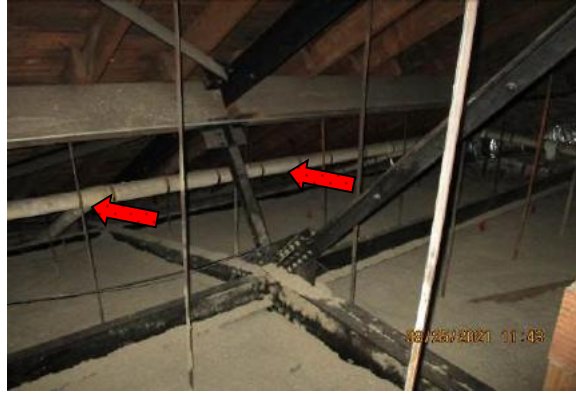
**Photo 6**

View of Asbestos-Containing Pipe/Fitting Insulation, 3<sup>rd</sup> Floor, Copy Room & Offices South & Attic Space East

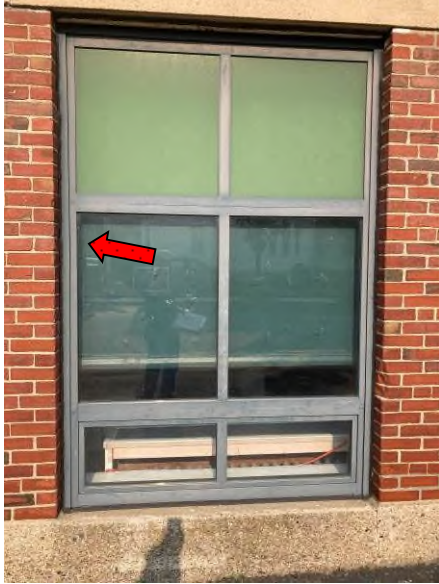
**Photo 1**

View of Asbestos-Containing Exterior Window Caulking

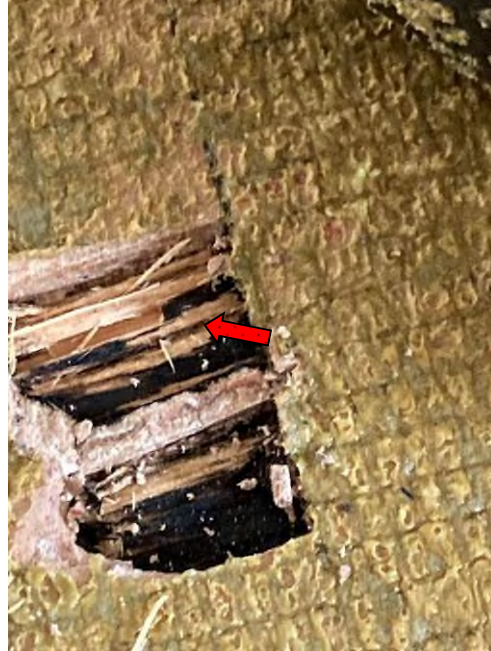
**Photo 2**

View of Asbestos-Containing 12" Pink Floor Tile Mastic

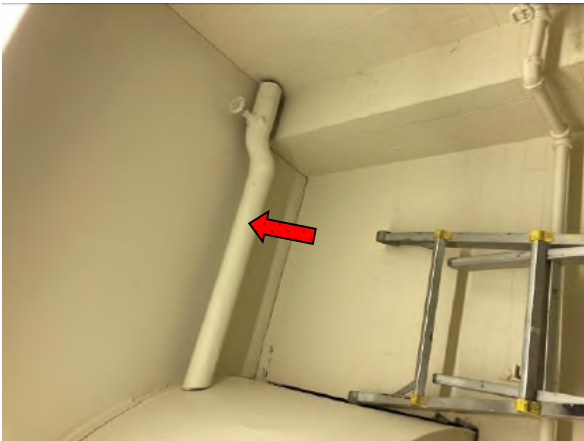
**Photo 3**

View of Asbestos-Containing Pipe Insulation

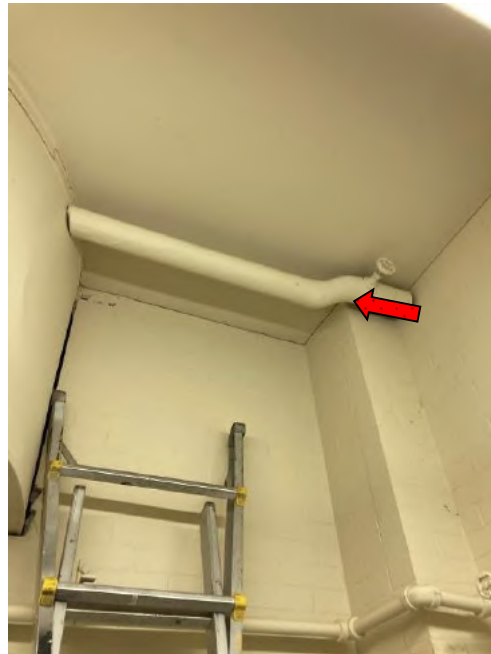
**Photo 4**

View of Asbestos-Containing Pipe Elbow Insulation

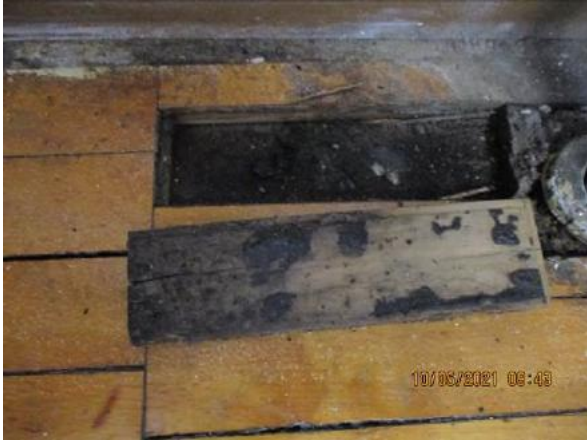
**Photo 5**

View of Asbestos-Containing Asphaltic Coating  
on Hardwood Planking
